Manhole Inspection Summary

Manhole # S31GG_049MH

Insp Date: 1/15/07 11:18 AM

Location Address: **1310 PARK AVE**

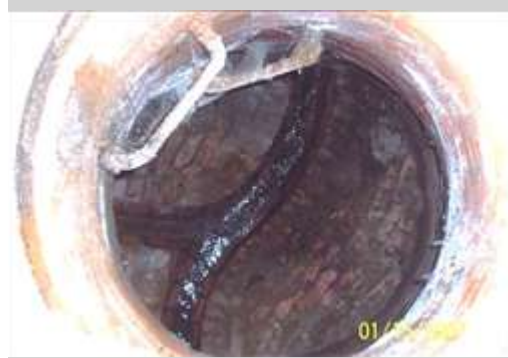
Top View

Corroded steps. Bench debris.

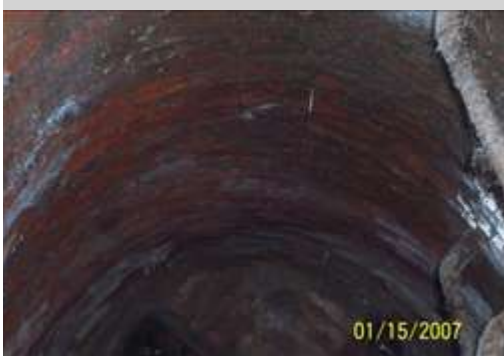
Defect

Corbel and Barrel infiltration.

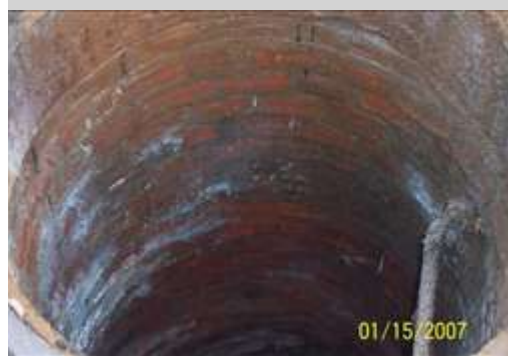
Defect

Frame leaks. Adjustment, Corbel and Barrel infiltration.

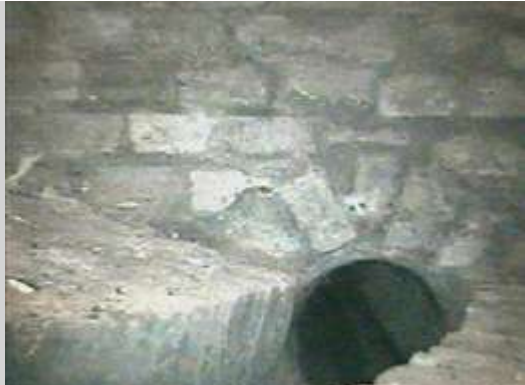
8 in. Circular Gravity Sewer Pipe Out @ 12 O'Clock

Invert Depth: **10.98** (ft.) Flow Characteristics: **Slow**

Deposits: ☒ None ☐ Mud ☐ Sludge ☐ Debris ☐ Grease

Infiltration: **None** Pipe Seal Cond: **Unknown**

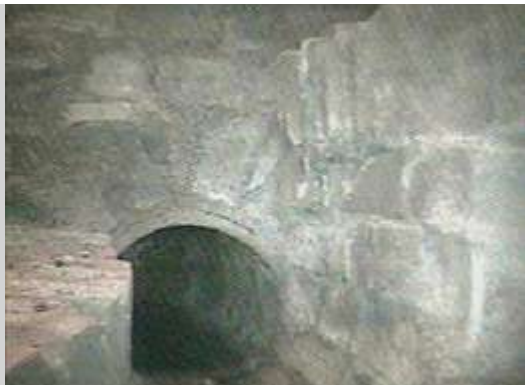
8 in. Circular Gravity Sewer Pipe In @ 7 O'Clock

Invert Depth: **10.80** (ft.) Flow Characteristics: **Slow**

Deposits: ☒ None ☐ Mud ☐ Sludge ☐ Debris ☐ Grease

Infiltration: **None** Pipe Seal Cond: **Unknown**

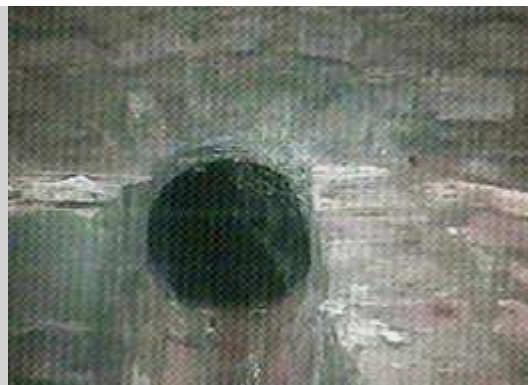
Pipe In @ 8 O'Clock

Invert Depth: **10.00** (ft.) Flow Characteristics: **Slow**

Deposits: ☐ None ☐ Mud ☐ Sludge ☐ Debris ☒ **Grease**

Deposits Extent: **Light**

Infiltration: **None**
